## Dead River Recovery Post-Event Additional Environmental Assessment: Survey of Morphological Stream Parameters Using Rosgen Method

Marquette County, Michigan

# Post-Event Environmental Assessment

Dead River, Michigan

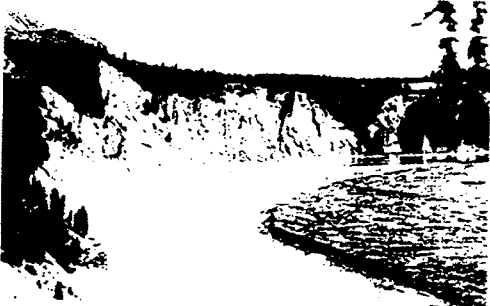
Mass wasting of slopes directly into the stream channel.

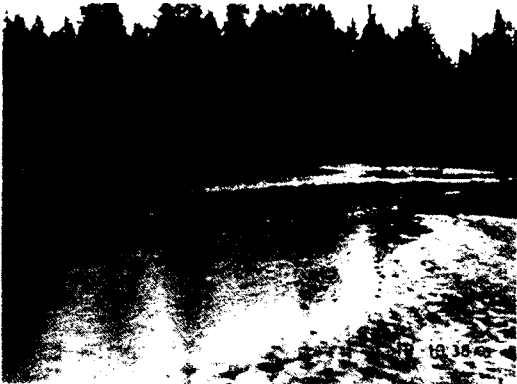
**Stream Sub-Reach R02-01 (downstream of County Road AAO Bridge, upstream of Dead River Storage Basin). R02-01-P09-N.JPG. From on top of sand deposition looking at riffle.**

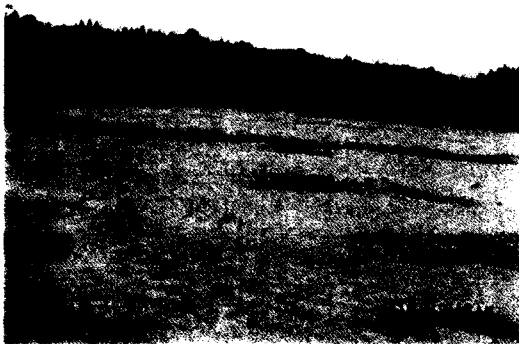
Reach 03. R03-P006-SE.JPG. Facing southeast. Sand deposit in upper Dead River Storage Basin.

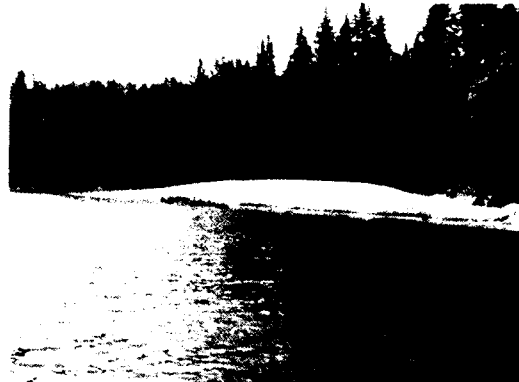
Reach 03. R02E-P205-SW.JPG. Facing southwest. Overbank sand deposit adjacent to apparent scoured channel just upstream of the Dead River Storage Basin.

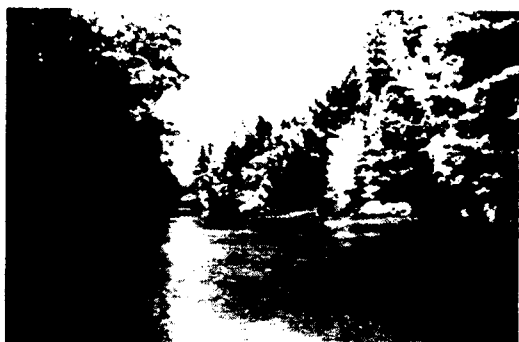
Stream Sub-Reach R04-01 (downstream of Dead River Storage Basin penstock release). R04-01-P01-SE.JPG. Looking downstream, vegetated gravel bar divides stream flow.

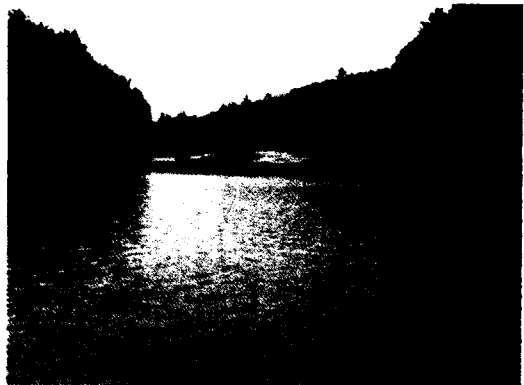
**Reach 07. R07-P096-W.JPG. Facing west. Sand deposits on the downstream end of a mid-channel island east of Forestville Road Bridge.**
