## Dead River Recovery Post-Event Additional Environmental Assessment: Survey of Morphological Stream Parameters Using Rosgen Method

Marquette County, Michigan

# Post-Event Environmental Assessment

Dead River, Michigan

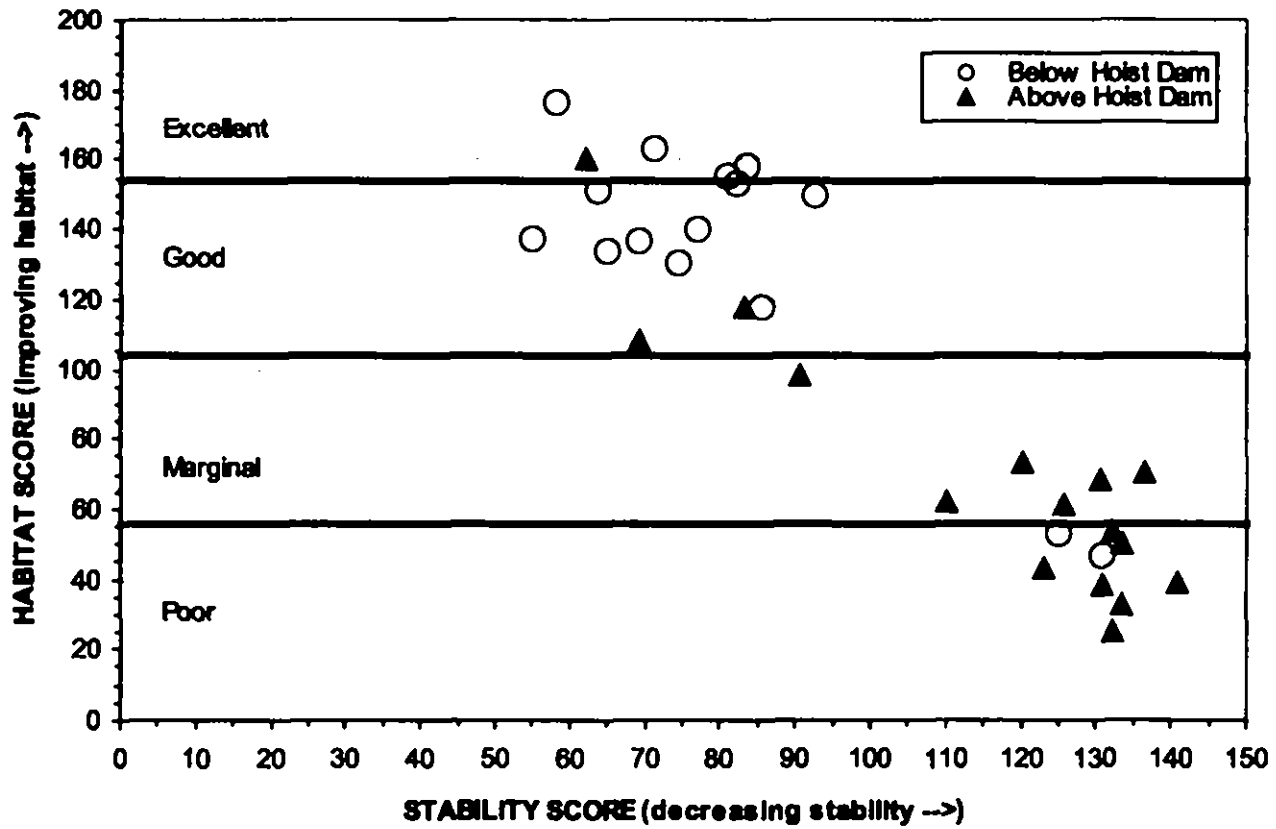
**FIGURE 3-3**  
**Total Stream Habitat Versus Stability Scores**  
**Post Event Environmental Assessment**

The general trend between the habitat and stability scores was an inversely proportional linear relationship (Figure 3-3). Increased stability in a stream system typically encourages improved habitat conditions for aquatic life. In turn, unstable stream conditions typically disturb good habitat conditions, and therefore stress aquatic life.

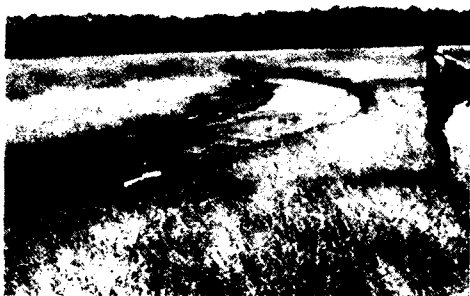
Stream Sub-Reach R01-03 (former Silver Lake Basin). R01-03-P109-S.JPG. Looking upstream.

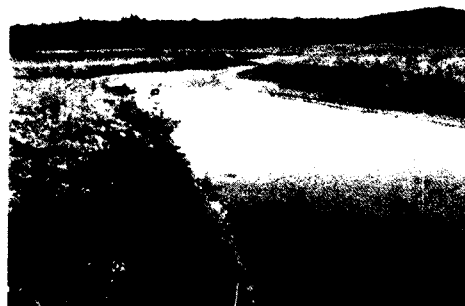
Stream Sub-Reach R01-02 (former Silver Lake Basin). R01-02-P102-W.JPG. Looking upstream.

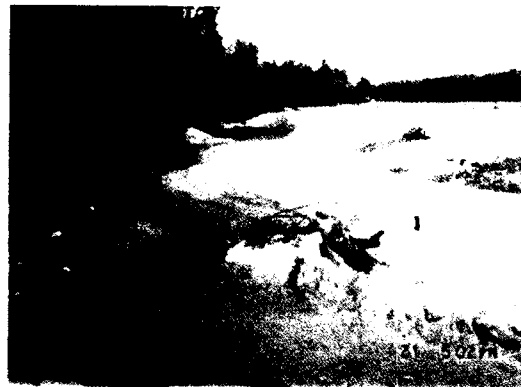
**Stream Sub-Reach R02-11 (downstream of R02-12, downstream of dam). R02-11-P150-NE.JPG.** Looking upstream toward ponded area (pond is not visible; it is behind sandbar).

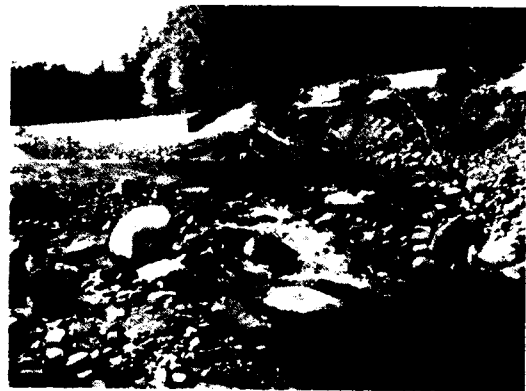
**Stream Sub-Reach R02-09. R02-09-P129-N.JPG.** Looking upstream at left bank.

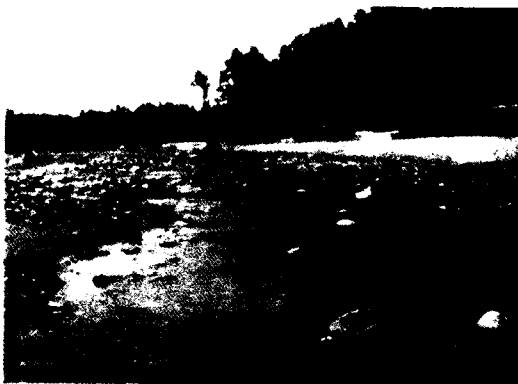
**Stream Sub-Reach R02-08. R02-08-P104-N.JPG.** Looking upstream at left bank.

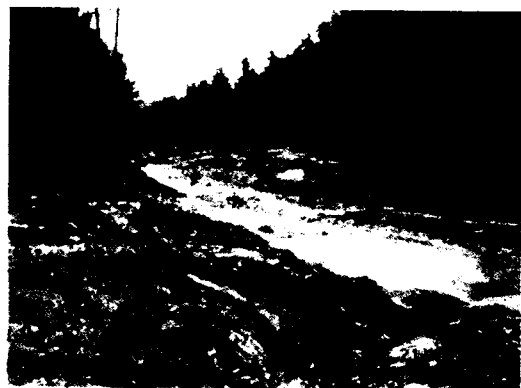
**Stream Sub-Reach R02-07 (upstream of Connors Creek). R02-07-P84-S.JPG.** Looking upstream at left bank.

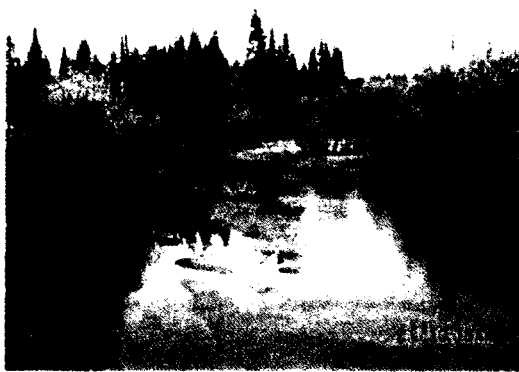
**Stream Sub-Reach R02-06 (Connors Creek confluence).** R02-06-P56-W.JPG. Looking upstream.

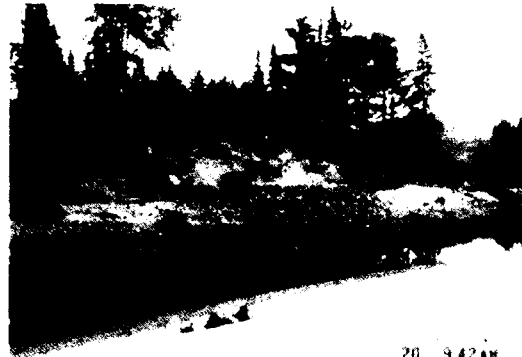
**Stream Sub-Reach R02-04 (upstream of Mulligan Creek confluence, high banks area).** R02-04-P19-SE.JPG. Looking upstream at main channel.

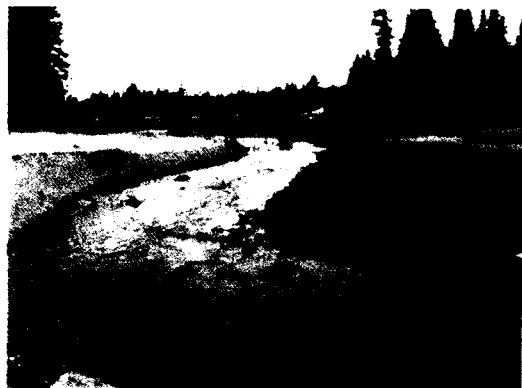
**Stream Sub-Reach R02-03 (at confluence with Mulligan Creek).** R02-03-P96-NW.JPG. Looking upstream.

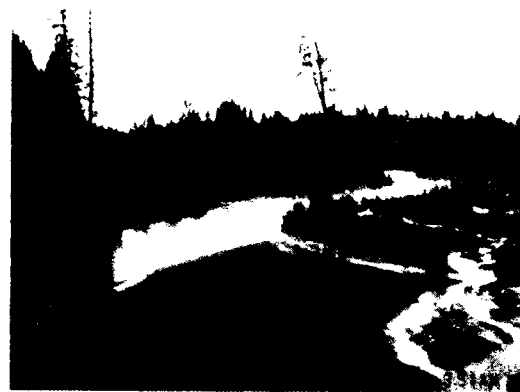
**Stream Sub-Reach R02-06.** R02-06-P47-S.JPG.  
Looking upstream near Connors Creek confluence with the Dead River.

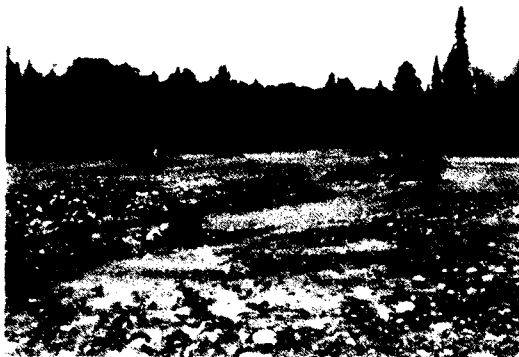
**Stream Sub-Reach R02-06.** R02-06-P66-N.JPG.  
Looking at left bank of high flow area near confluence of Connors Creek and the Dead River.

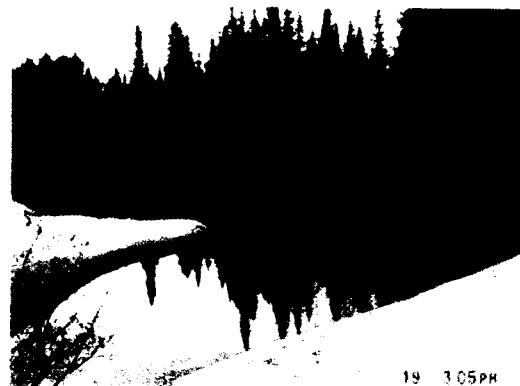
**Stream Sub-Reach R02-03.** R02-03-P99-NW.JPG.  
Downstream end of Mulligan Creek, looking up Mulligan Creek. Mouth is blocked with sand.

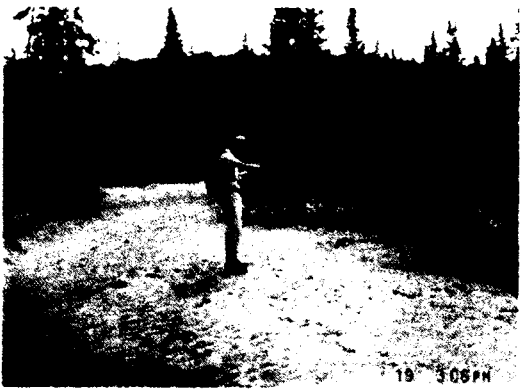
**Stream Sub-Reach R02-03. R02-03-P100-SW.JPG.**  
Looking across sand deposition at mouth of Mulligan Creek. Dead River is behind photographer.

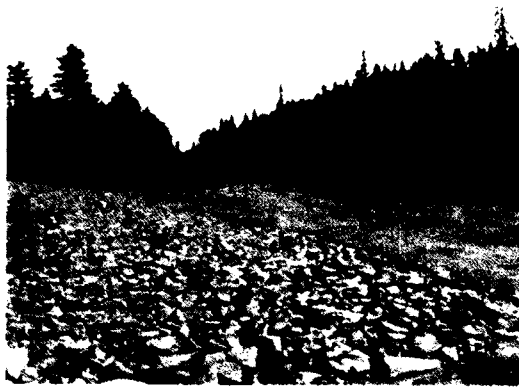
**Stream Sub-Reach R02-03. R02-03-P72-N.JPG.**  
Looking upstream of County Road AAO Bridge.

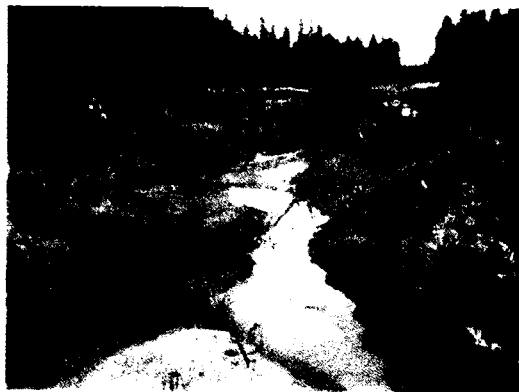
**Stream Sub-Reach R02-01. R02-01-P33-N.JPG.** Side channel forming downstream of County Road AAO Bridge, potential wetland area.

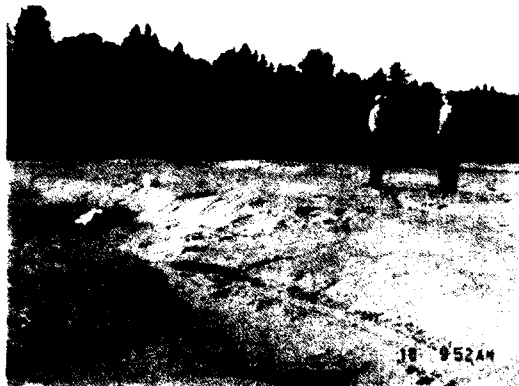
Reach 03. R03-P010-S.JPG. Facing south. Sand deposit in upper Dead River Storage Basin.

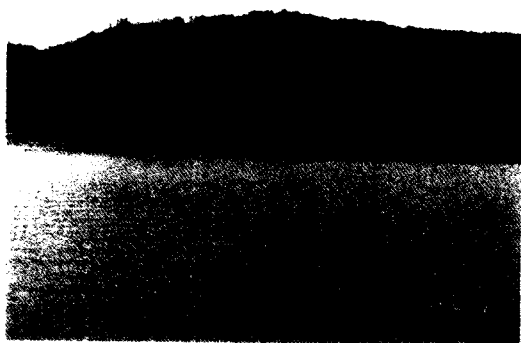
**Reach 05.** R05-P081-W.JPG. Facing west. Looking upstream at County Road 510 bridge.

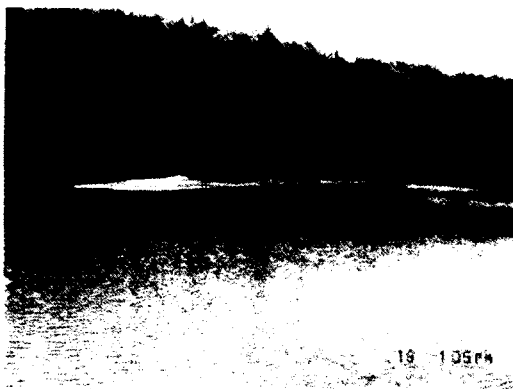
**Reach 05.** R05-P084-S.JPG. Facing south. Looking across channel from the boat ramp.

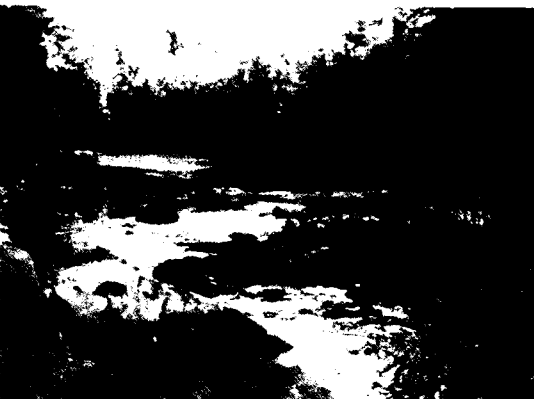
**Stream Sub-Reach R06-04 (upstream of waterfalls). R06-04-P25-NE.JPG.**  
Riffle, looking upstream.

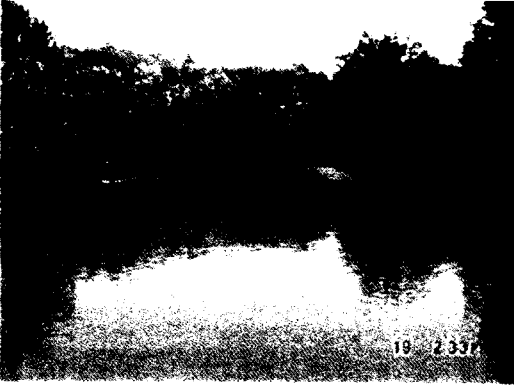
**Reach 07. R07-P090-E.JPG. Facing east. Typical reach photo looking d/s in the riverine backwater approach channel to the reservoir (upstream of the boat ramp).**

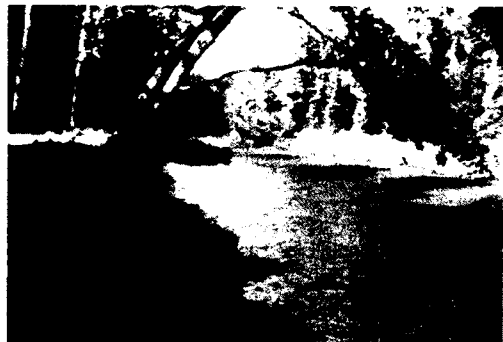
**Stream Sub-Reach R08-01 (downstream of Forestville penstock release).** R08-01-P05-W.JPG. Looking upstream at high flow.

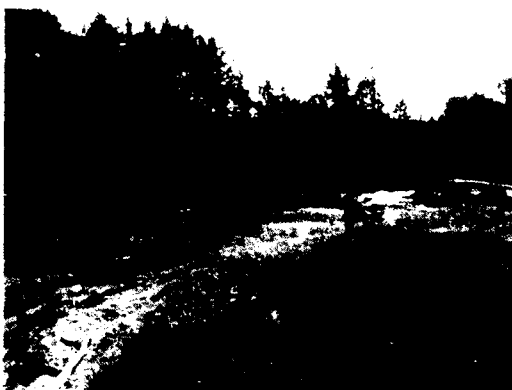
**Stream Sub-Reach R09-01.** R09-01-P04-SE.JPG.  
Sand point bar at bend in Dead River just upstream of  
Tourist Park Basin, looking downstream.

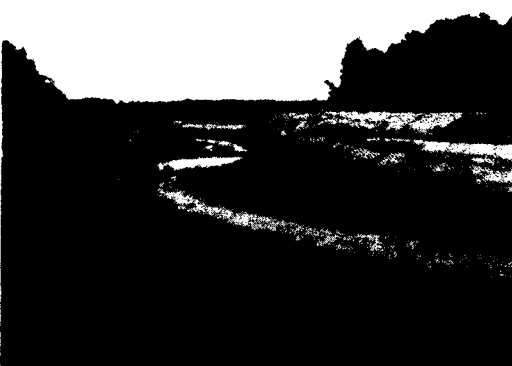
**Stream Sub-Reach R09-01.** R09-01-P15-E.JPG.  
Looking downstream at split flow around island  
(low flow conditions).

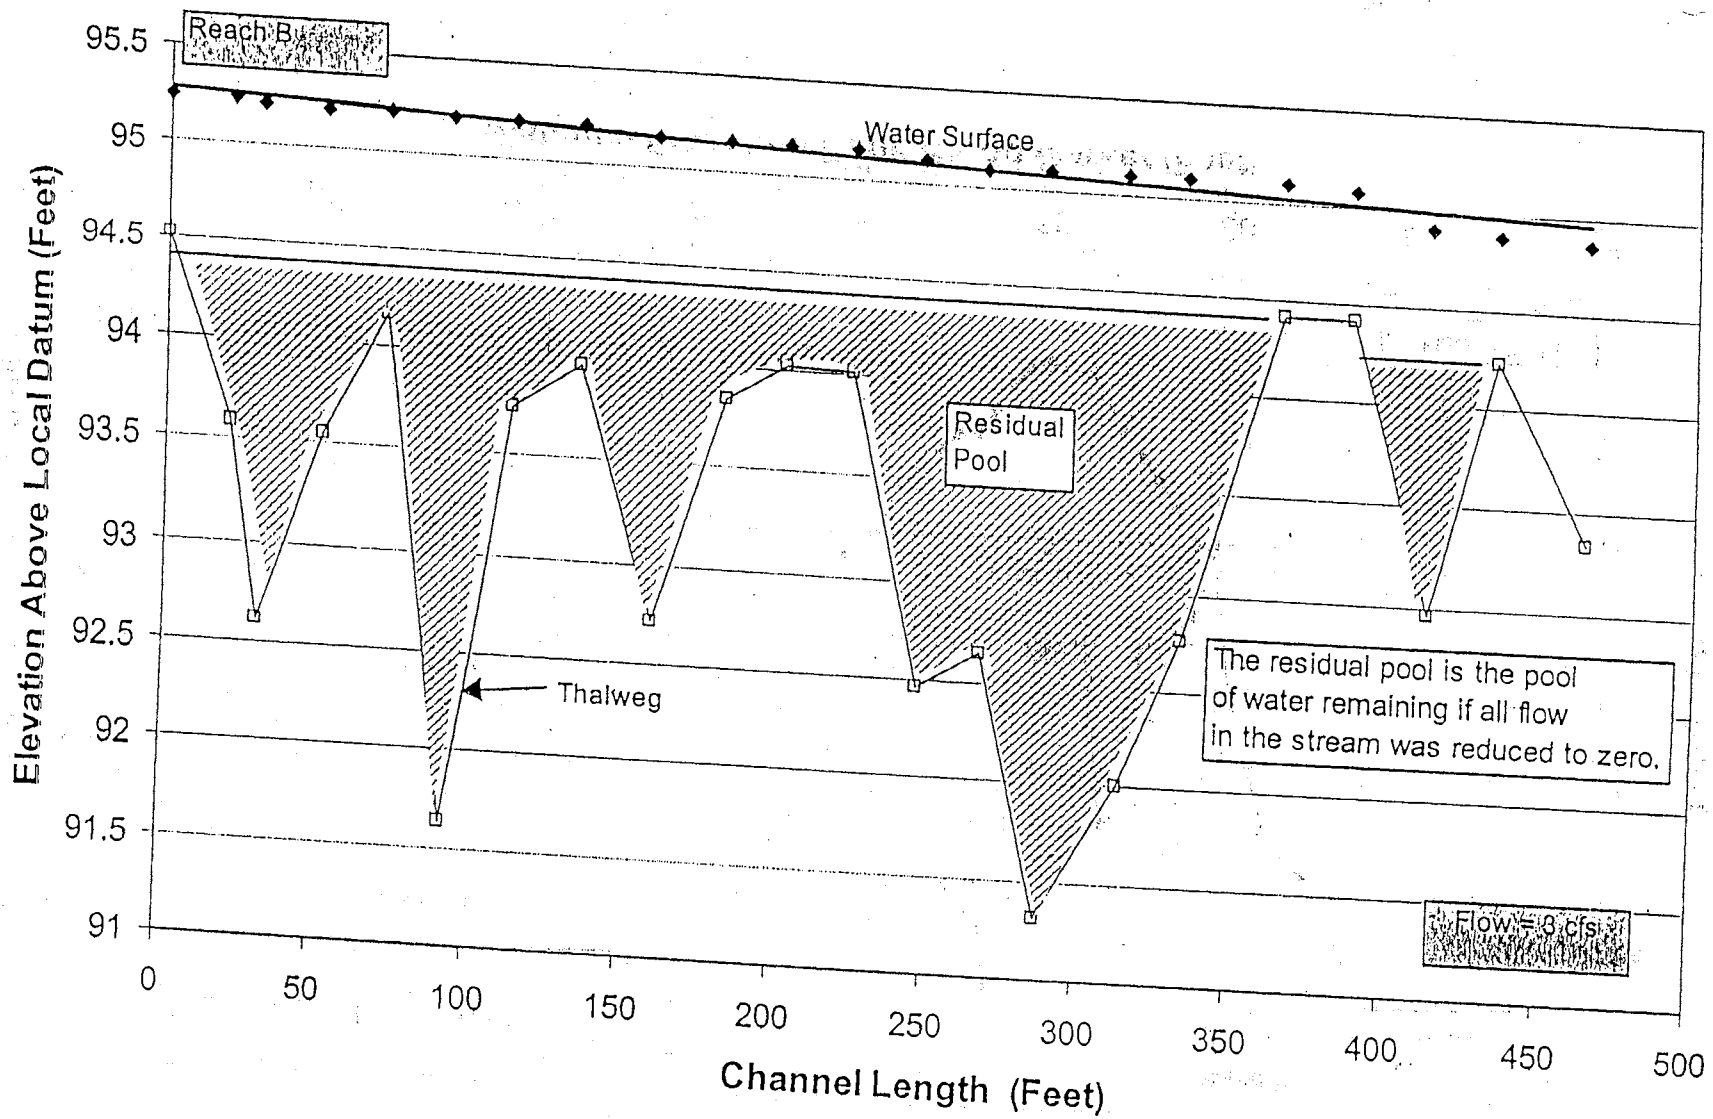
Figure 9. Longitudinal profile of Reach B on August 9, 2000.

Reach B was 464 feet long with sand substrate and was generally narrower than Reach A. The stream was approximately 20 feet wide, with average cross-sectional depths of 1-2.5 feet. Velocities at individual points in the three transects ranged from 0 to 0.5 feet per second (fps), but almost all locations were unmeasurable (<0.1 fps). This reach had areas of dense aquatic macrophytes and a few small log jams (Figure 8). The riparian zone was composed of tag alder (*Alnus sp.*), with hard maples and hemlock above the floodplain. Instream habitat included pools and riffles (Figure 9).

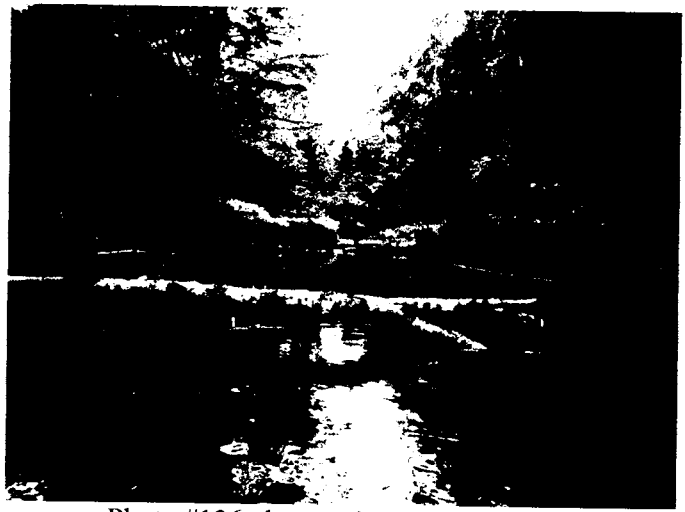
Photo #126 photo point #6 downstream

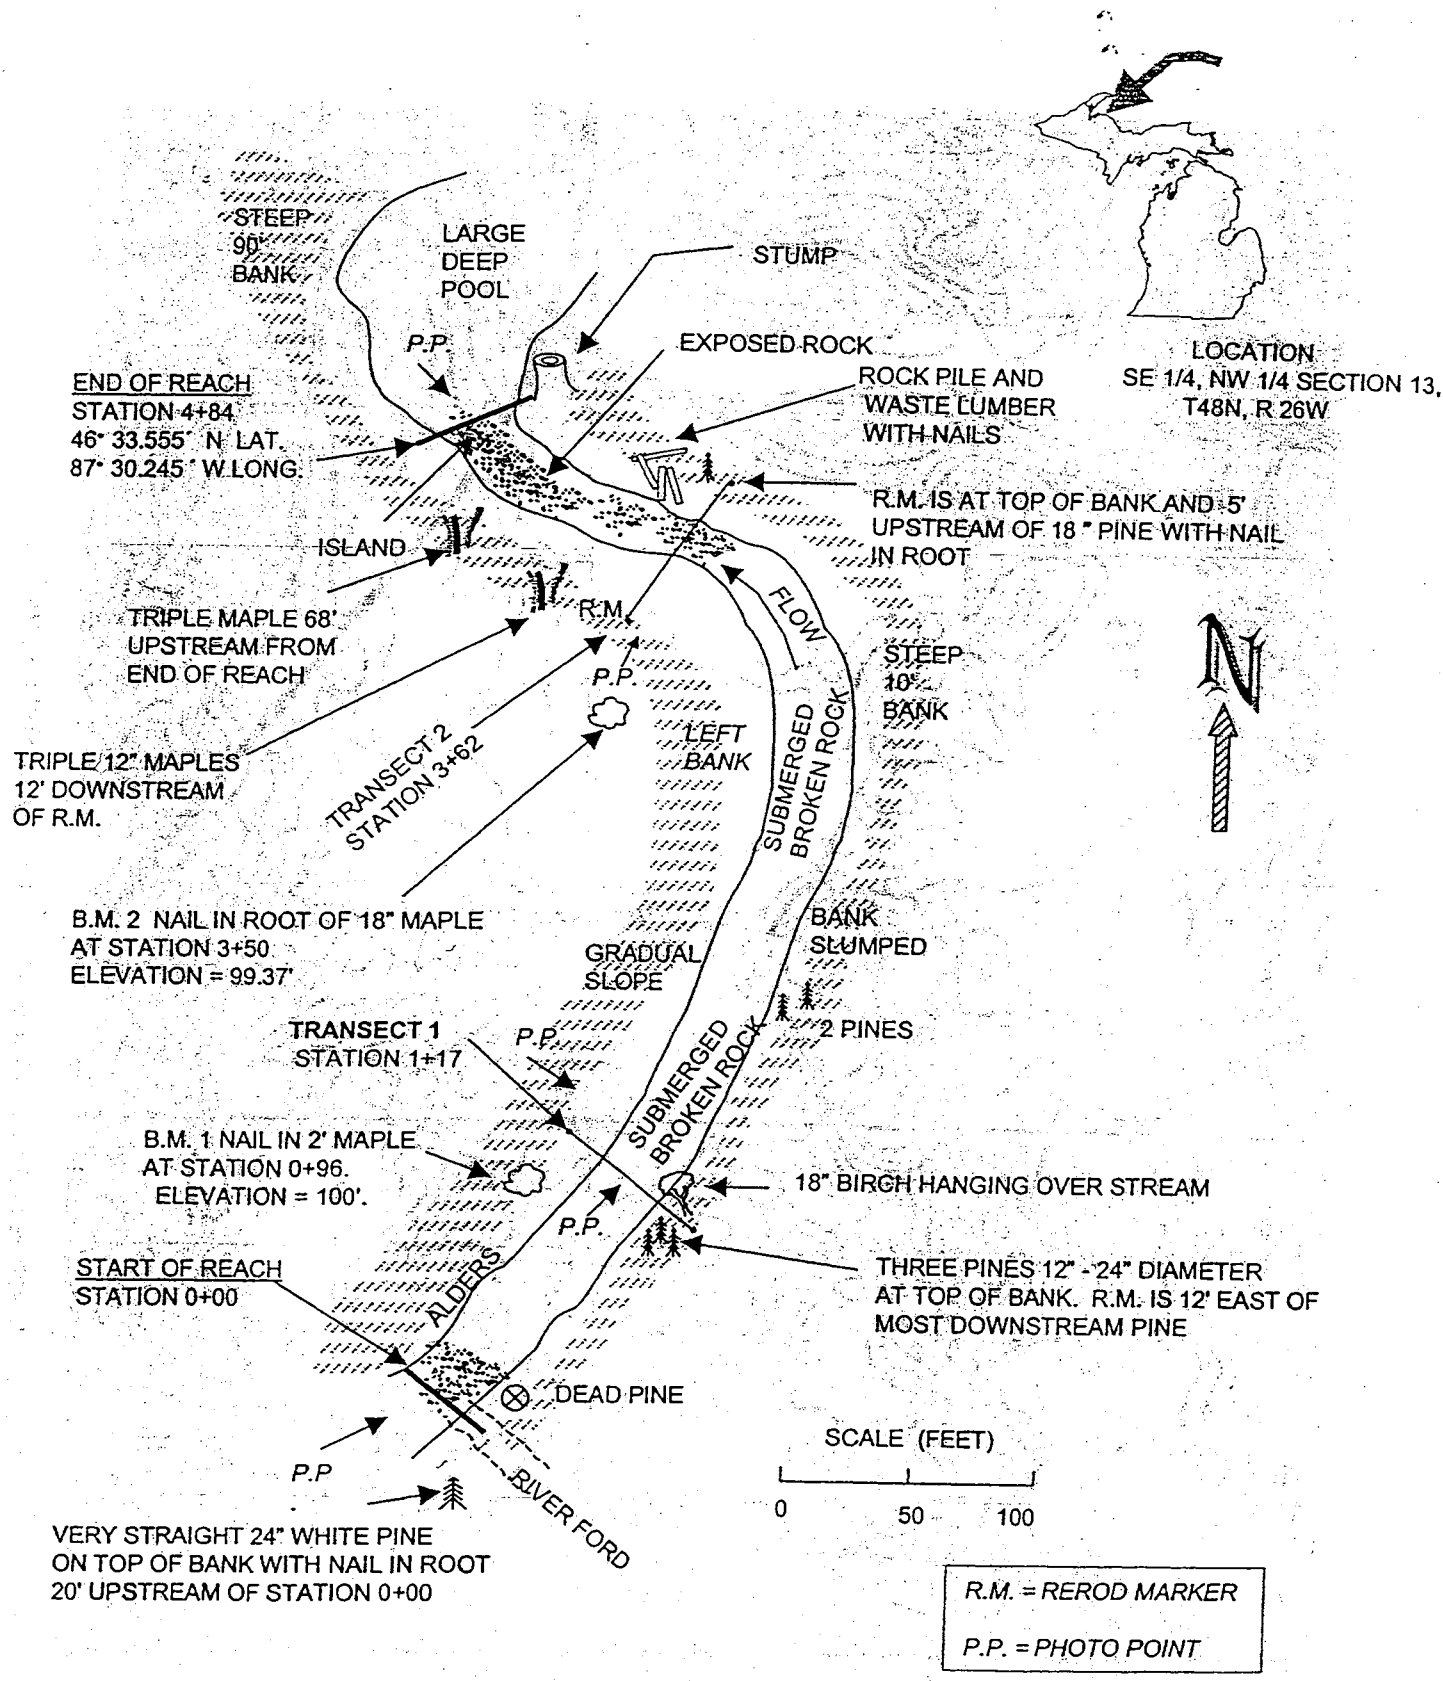
Reach A was the uppermost reach in this study, and was located just downstream of the LS&I railroad trestle. The reach was 484 feet long, and shallow with a rocky substrate. The upper 250 feet of this reach was characterized by an average depth of 1 foot, barely perceptible velocity (<0.1 foot/sec), and channel widths of approximately 40-45 feet. The lower 236 feet of this reach had a relatively high gradient and velocity, with widths of 25-40 feet and a depth of only about 0.3 feet. Large fractured bedrock in the riffles resulted in turbulent flows in the stream channel. Depths were too shallow to submerge the current meter and therefore velocity observations could not be made. The GLEAS staff estimated flow to be 1.5 cfs based on best professional judgment. There were two residual pools in this reach (Figure 5) with maximum depths of approximately 1.7 feet and 0.3 feet. Residual pools are those that remain if all flow to the stream was ceased and the channel drained down to the pools. Aquatic macrophytes were absent, but pool areas had abundant algal growth. The stream banks in Reach A were predominantly covered by mature maple-hemlock forest, although there was very little woody debris in the channel. This reach was affected by the low volume of water it receives, a lack of woody debris, and the rocky channel.

Figure 4. Map of Reach A on the Dead River bypassed channel, August 2000.

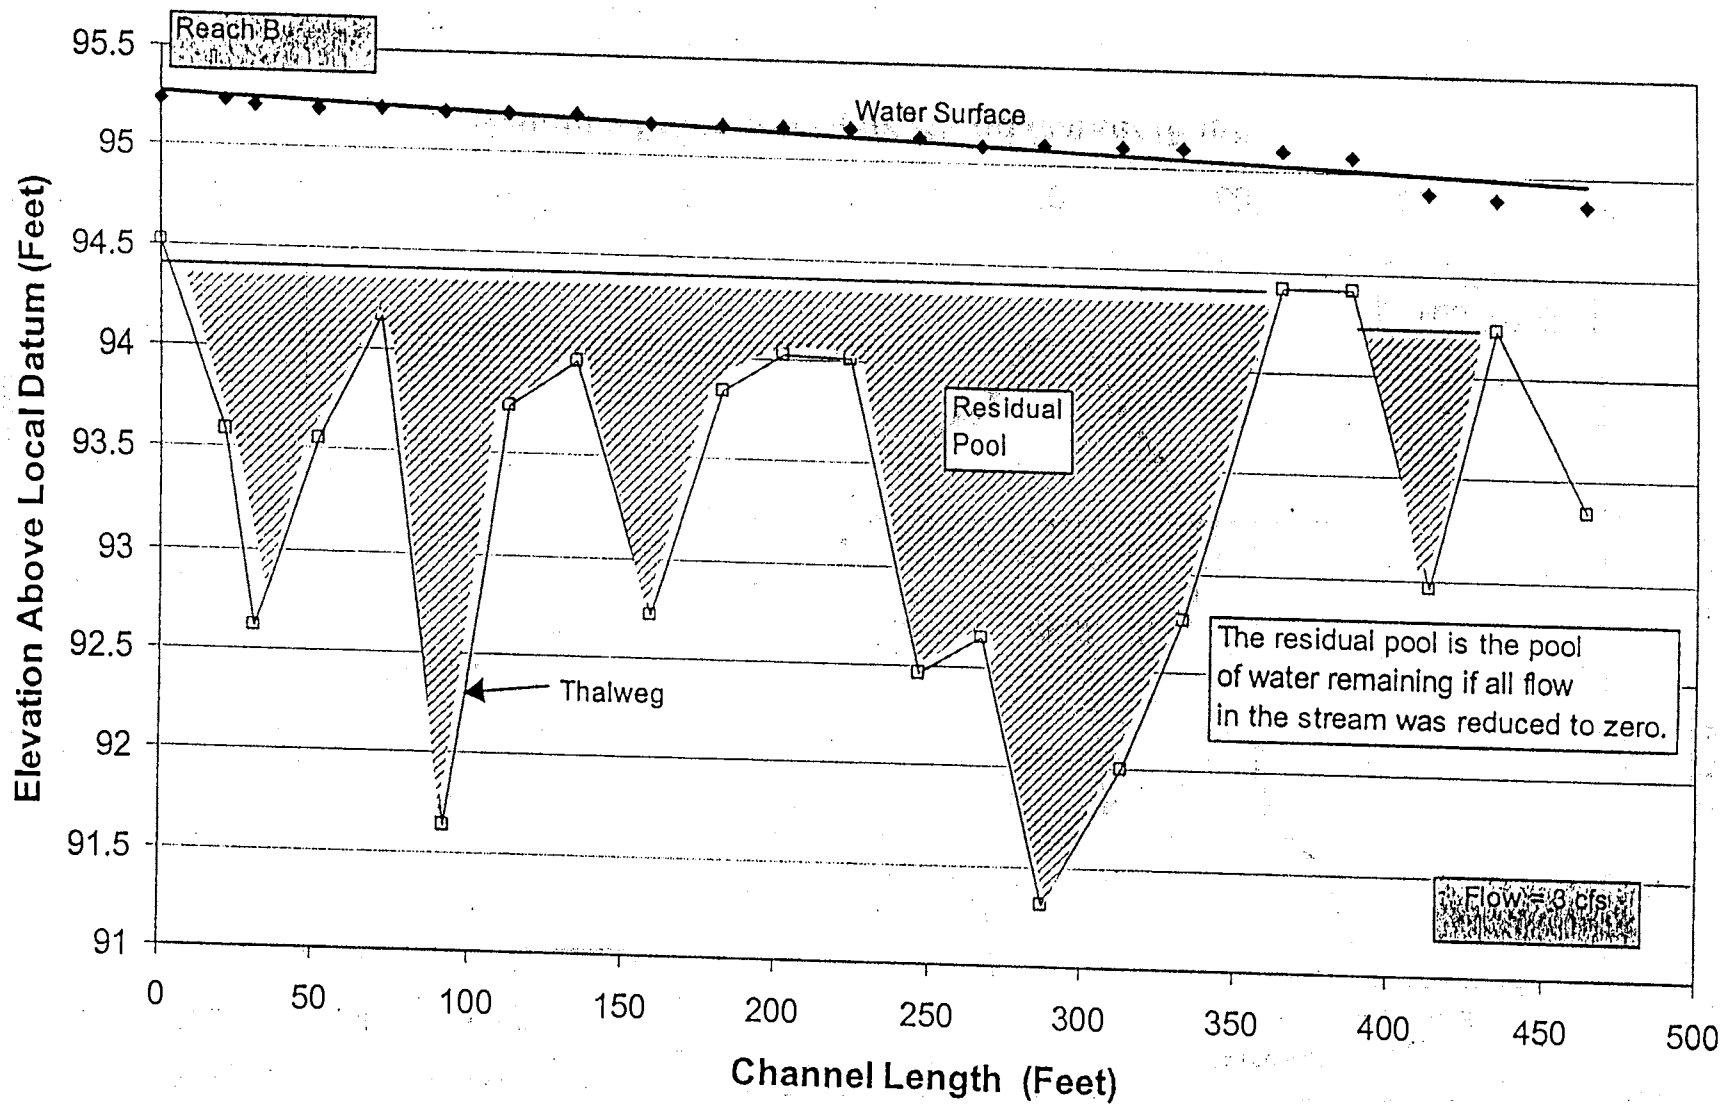
Figure 9. Longitudinal profile of Reach B on August 9, 2000.

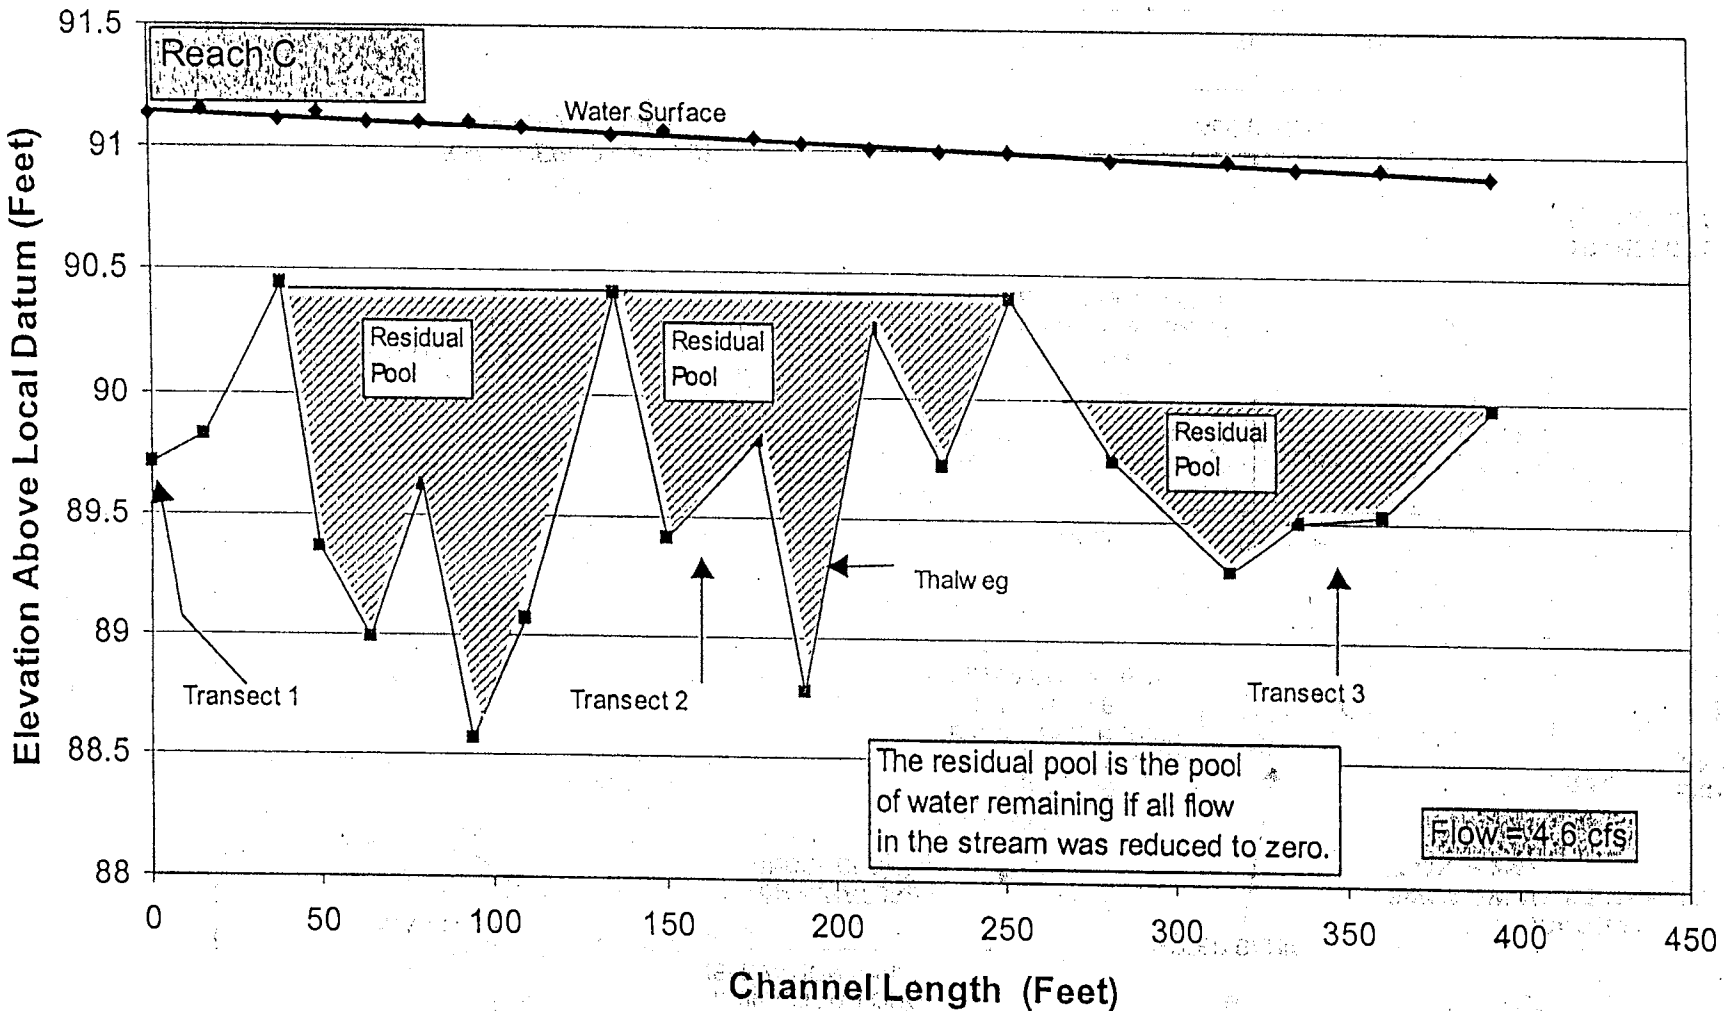
Reach C was 392 feet long with sand and organic substrate and was more narrow and shallow than Reach B. Stream widths were 10-25 feet and average cross-sectional depths were 0.5-1.0 feet. Average cross-sectional velocities measured in this reach (0.22-0.51 fps) were greater than the other two reaches. The reach contained some woody debris and macrophytes similar to Reach B. Instream habitats included pools and riffles (Figure 14).

Figure 14. Longitudinal profile of Reach C on August 8, 2000.

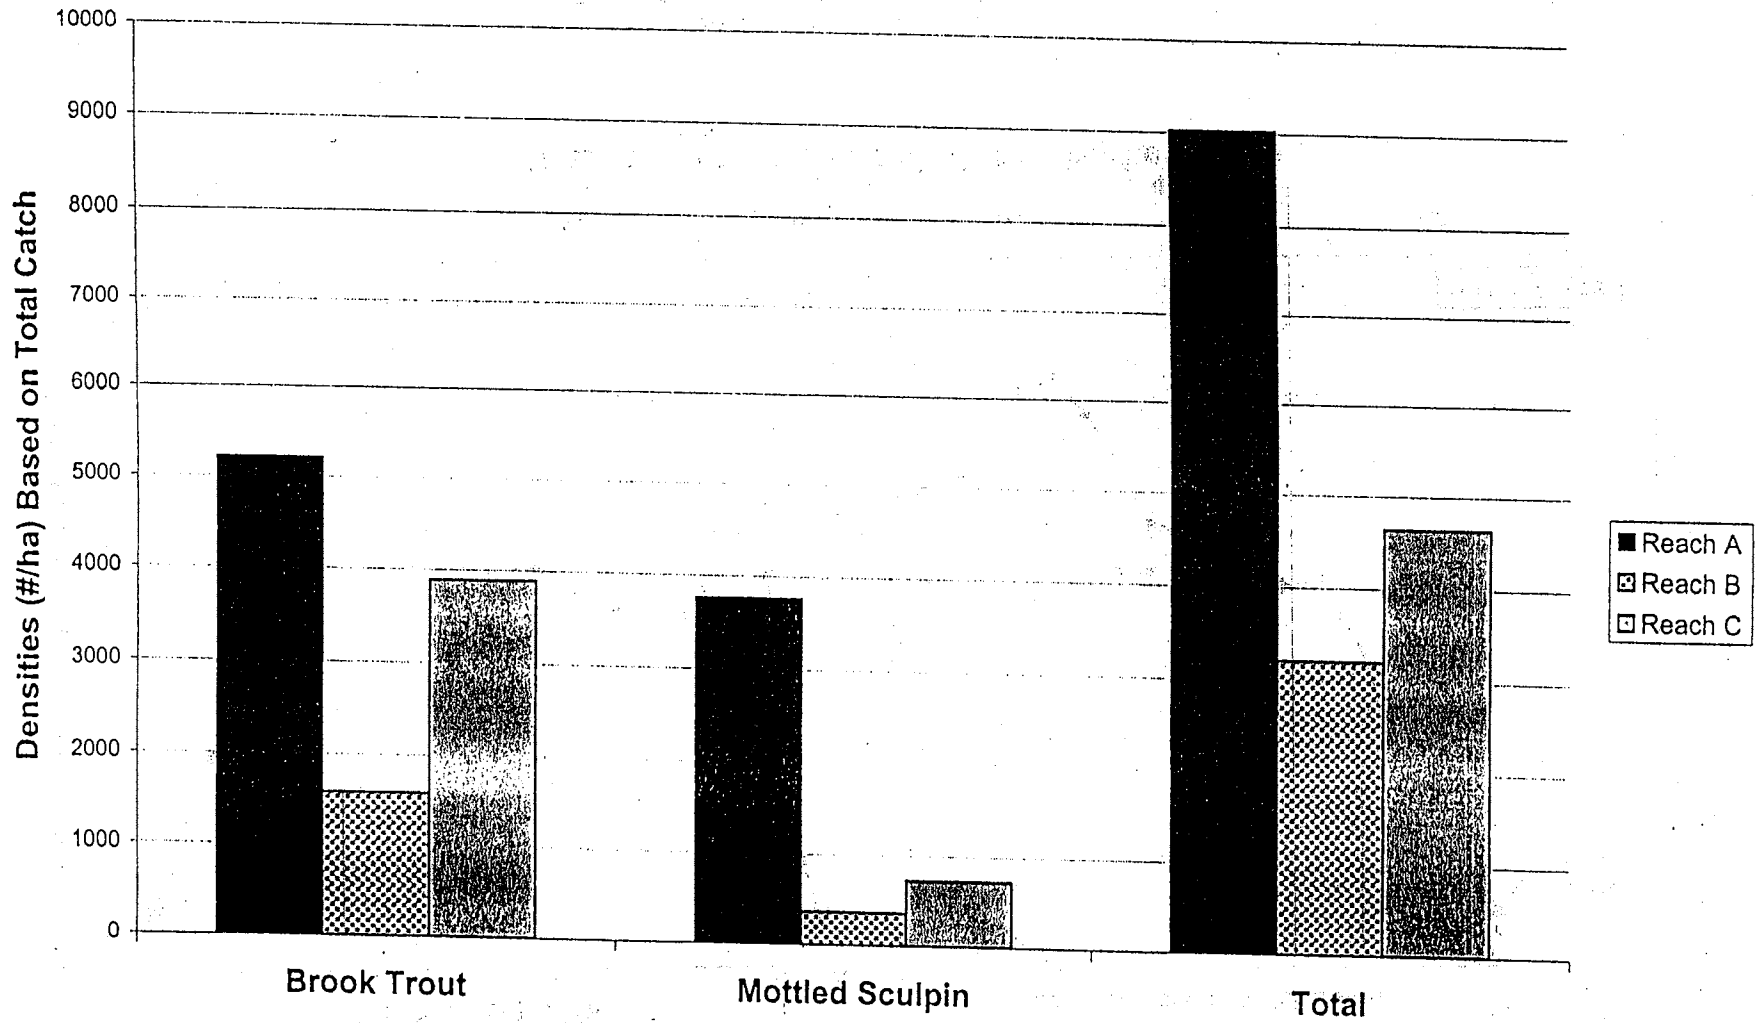
Of the study reaches, Reach A had the highest densities (#/ha) of brook trout, mottled sculpin, and total fish (Figure 18), as well as the greatest biomass (g/ha), or standing crop, of mottled sculpin and total fish (Table 13, Figure 19).

Figure 18. Densities (#/ha) of brook trout (*S. fontinalis*), mottled sculpin (*C. bairdi*), and total fish in Reaches A, B, and C of the Dead River bypassed channel, August 2000.

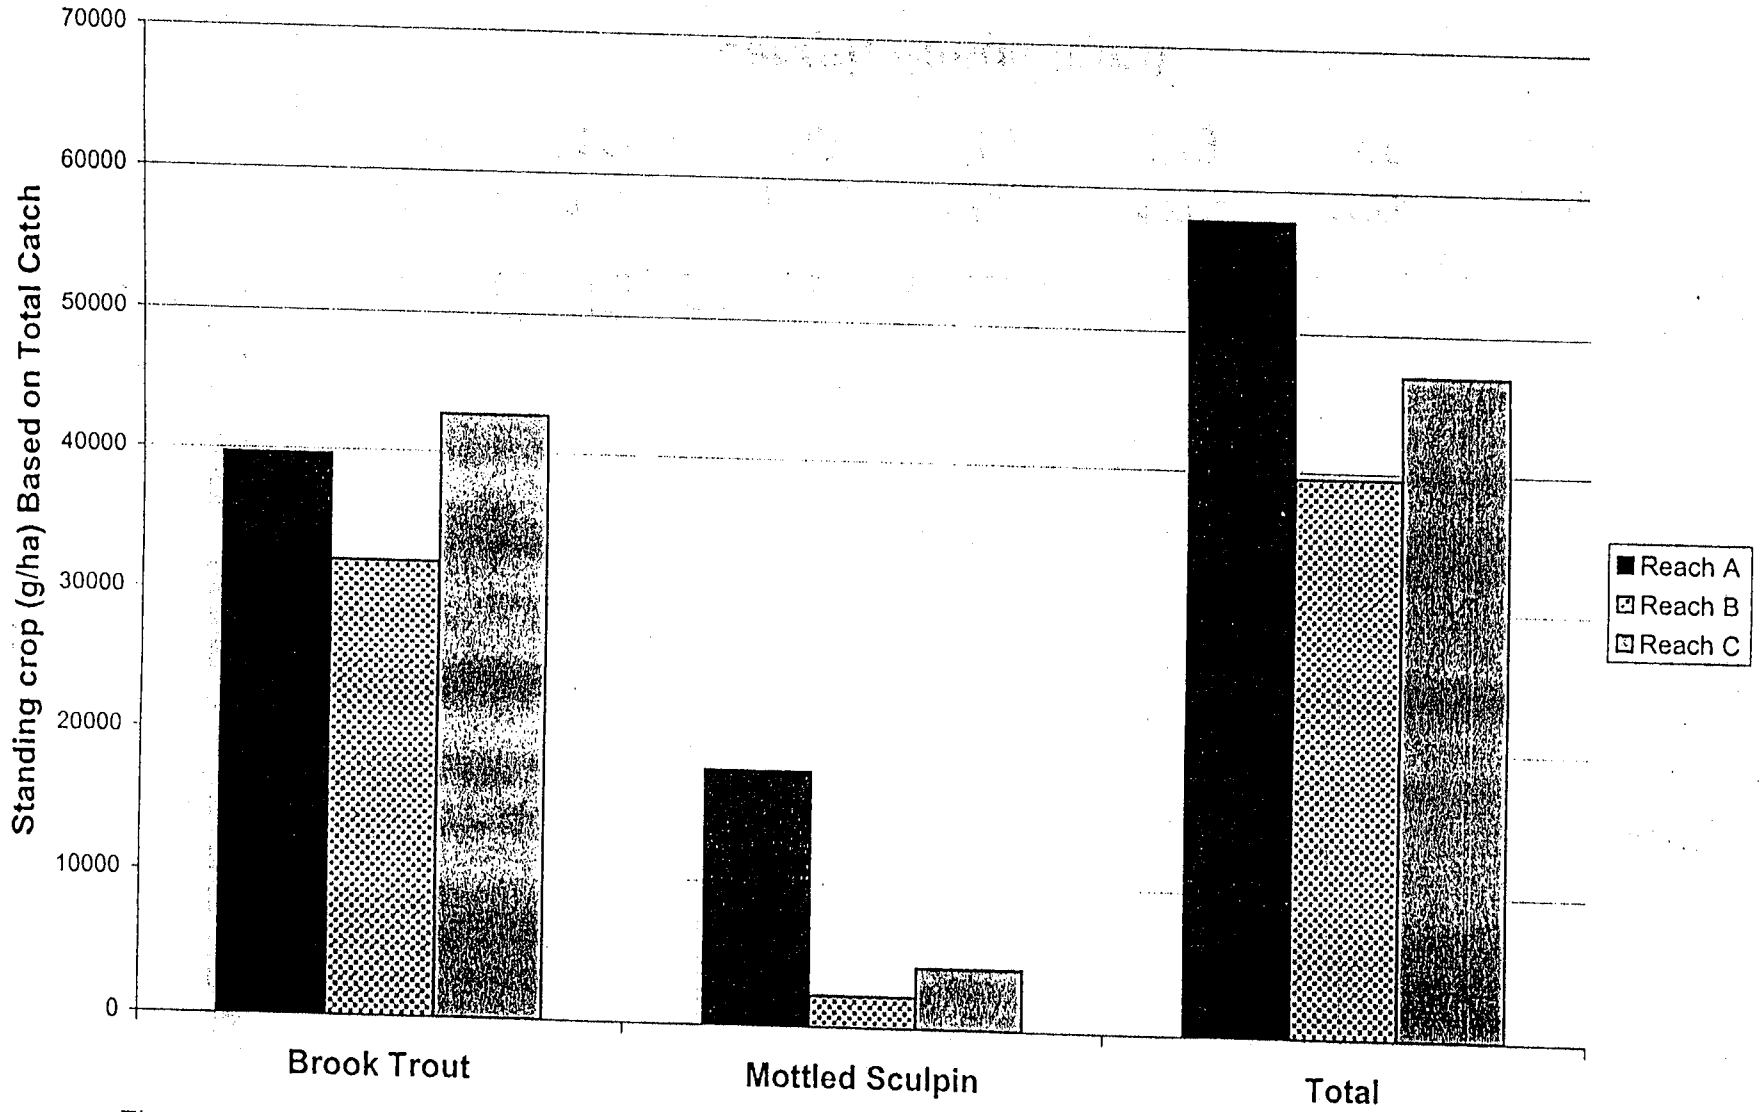
Brook trout (1582/ha) was the most abundant fish species in Reach B, followed by bluntnose minnow (598/ha) and mottled sculpin (372/ha) (Table 15). The presence of more pool habitat at Reach B seemed to improve the length-frequency distribution of the brook trout population (Figure 21). Only 39% of the brook trout found here were YOY, compared to 77% and 73% in Reaches A and C, respectively. Of the 119 brook trout captured in this reach, 9 were of legal size (7.6%). Despite the better length distribution of brook trout, Reach B ranked third in biomass due to lower overall fish density (Table 13, Figure 19).

Figure 19. Standing crop (g/ha) of brook trout (*S. fontinalis*), mottled sculpin (*C. bairdi*), and total fish in Reaches A, B, and C of the Dead River bypassed channel, August 2000.

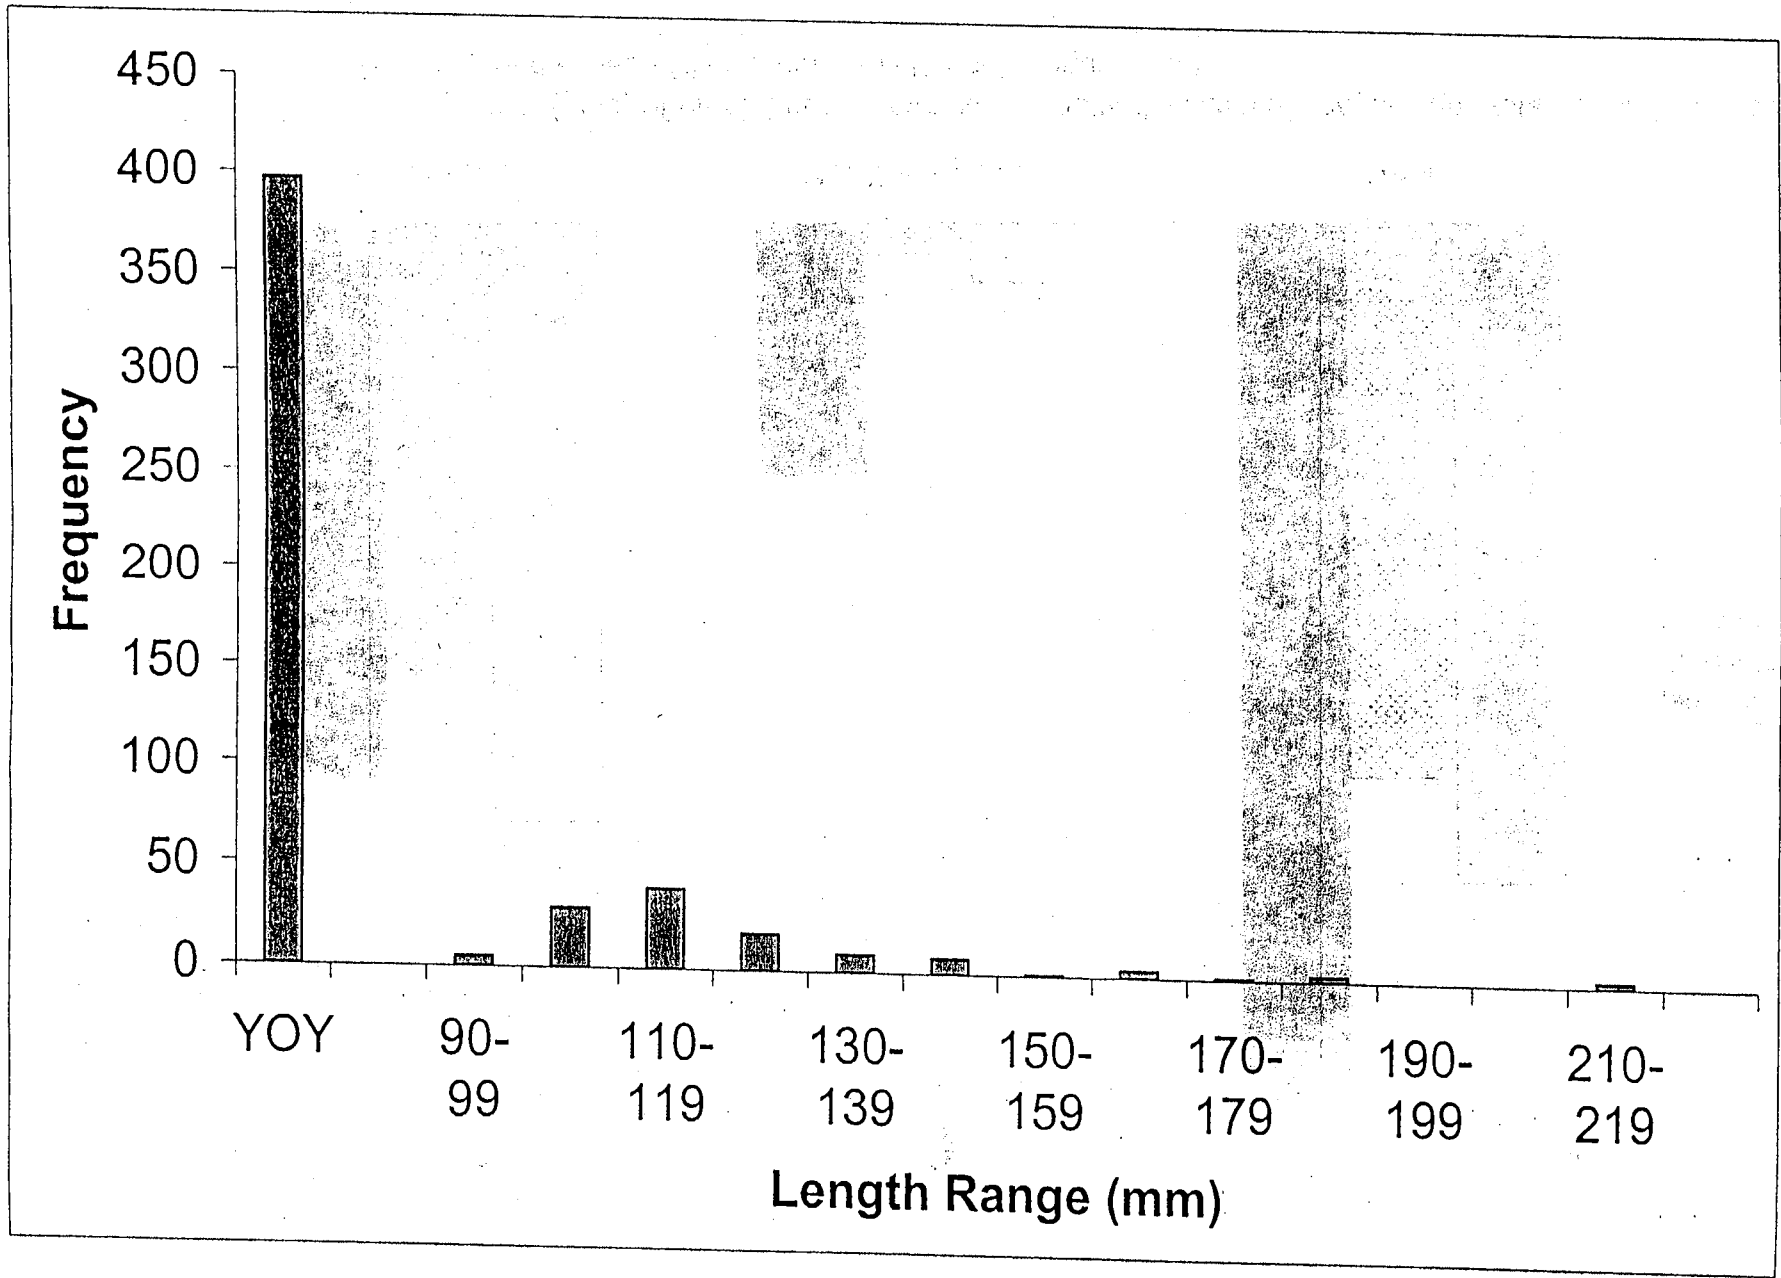
Reach A had excellent shallow-water nursery habitat for young salmonids, but lacked sufficient deep water habitat to support older trout. Fish species found in Reach A were, in decreasing order of abundance, brook trout (*Salvelinus fontinalis*), mottled sculpin (*Cottus bairdi*), blacknose dace (*Rhinichthys atratulus*), brown trout (*Salmo trutta*), and bluntnose minnow (*Pimephales notatus*). Brook trout (5214 per hectare) and mottled sculpin (3772 per hectare) were by far the most abundant taxa encountered (Table 14). Seventy-seven percent of the brook trout captured in this reach were YOY (Figure 20). Only 6 of the 517 brook trout (1.2%) captured were of legal size (7 inches or longer).

Figure 20. Length-frequency chart for brook trout in Reach A of the Dead River bypassed channel, August 2000.
