## Dead River Recovery Post-Event Additional Environmental Assessment: Survey of Morphological Stream Parameters Using Rosgen Method

Marquette County, Michigan

# Post-Event Environmental Assessment

Dead River, Michigan

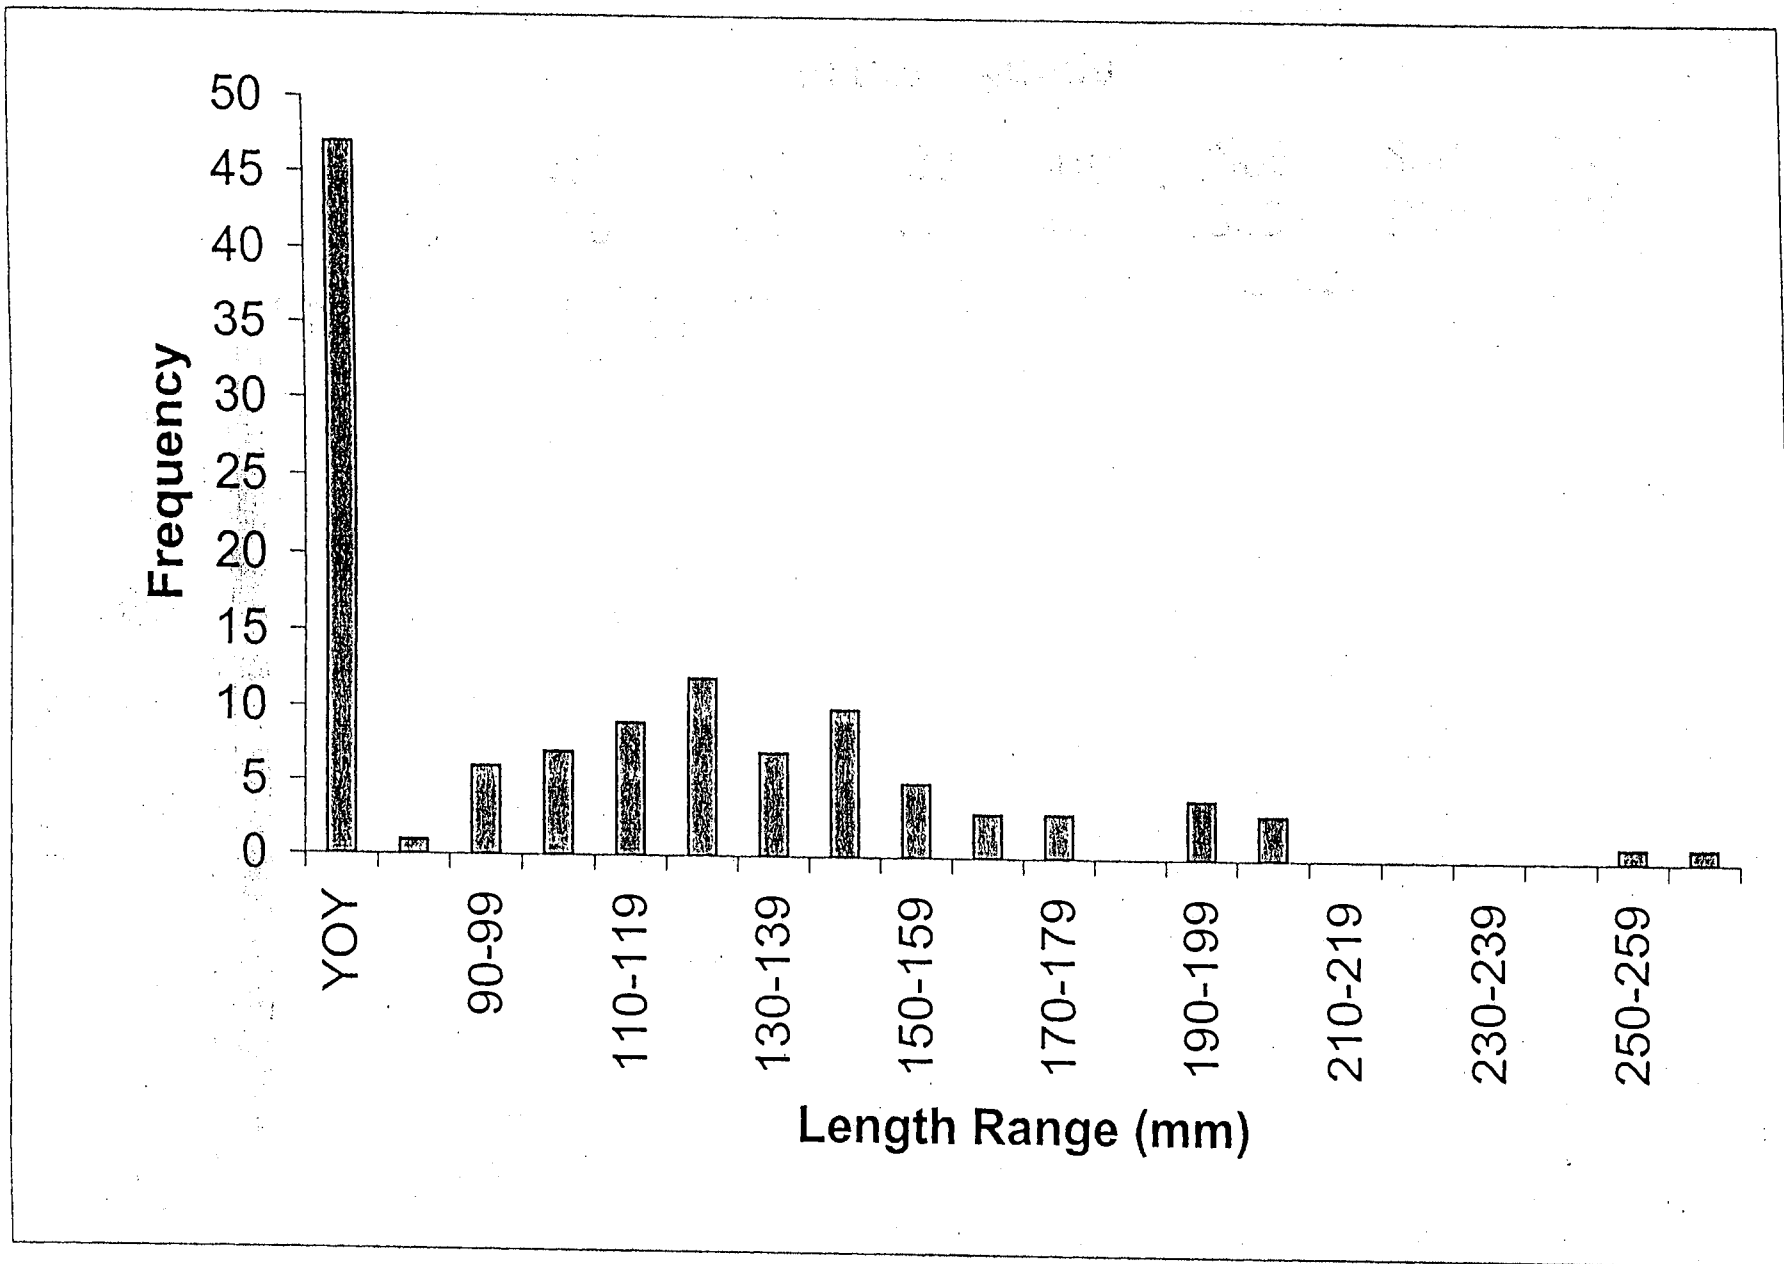
Brook trout (1582/ha) was the most abundant fish species in Reach B, followed by bluntnose minnow (598/ha) and mottled sculpin (372/ha) (Table 15). The presence of more pool habitat at Reach B seemed to improve the length-frequency distribution of the brook trout population (Figure 21). Only 39% of the brook trout found here were YOY, compared to 77% and 73% in Reaches A and C, respectively. Of the 119 brook trout captured in this reach, 9 were of legal size (7.6%). Despite the better length distribution of brook trout, Reach B ranked third in biomass due to lower overall fish density (Table 13, Figure 19).

Figure 21. Length-frequency chart for brook trout in Reach B of the Dead River bypassed channel, August 2000.

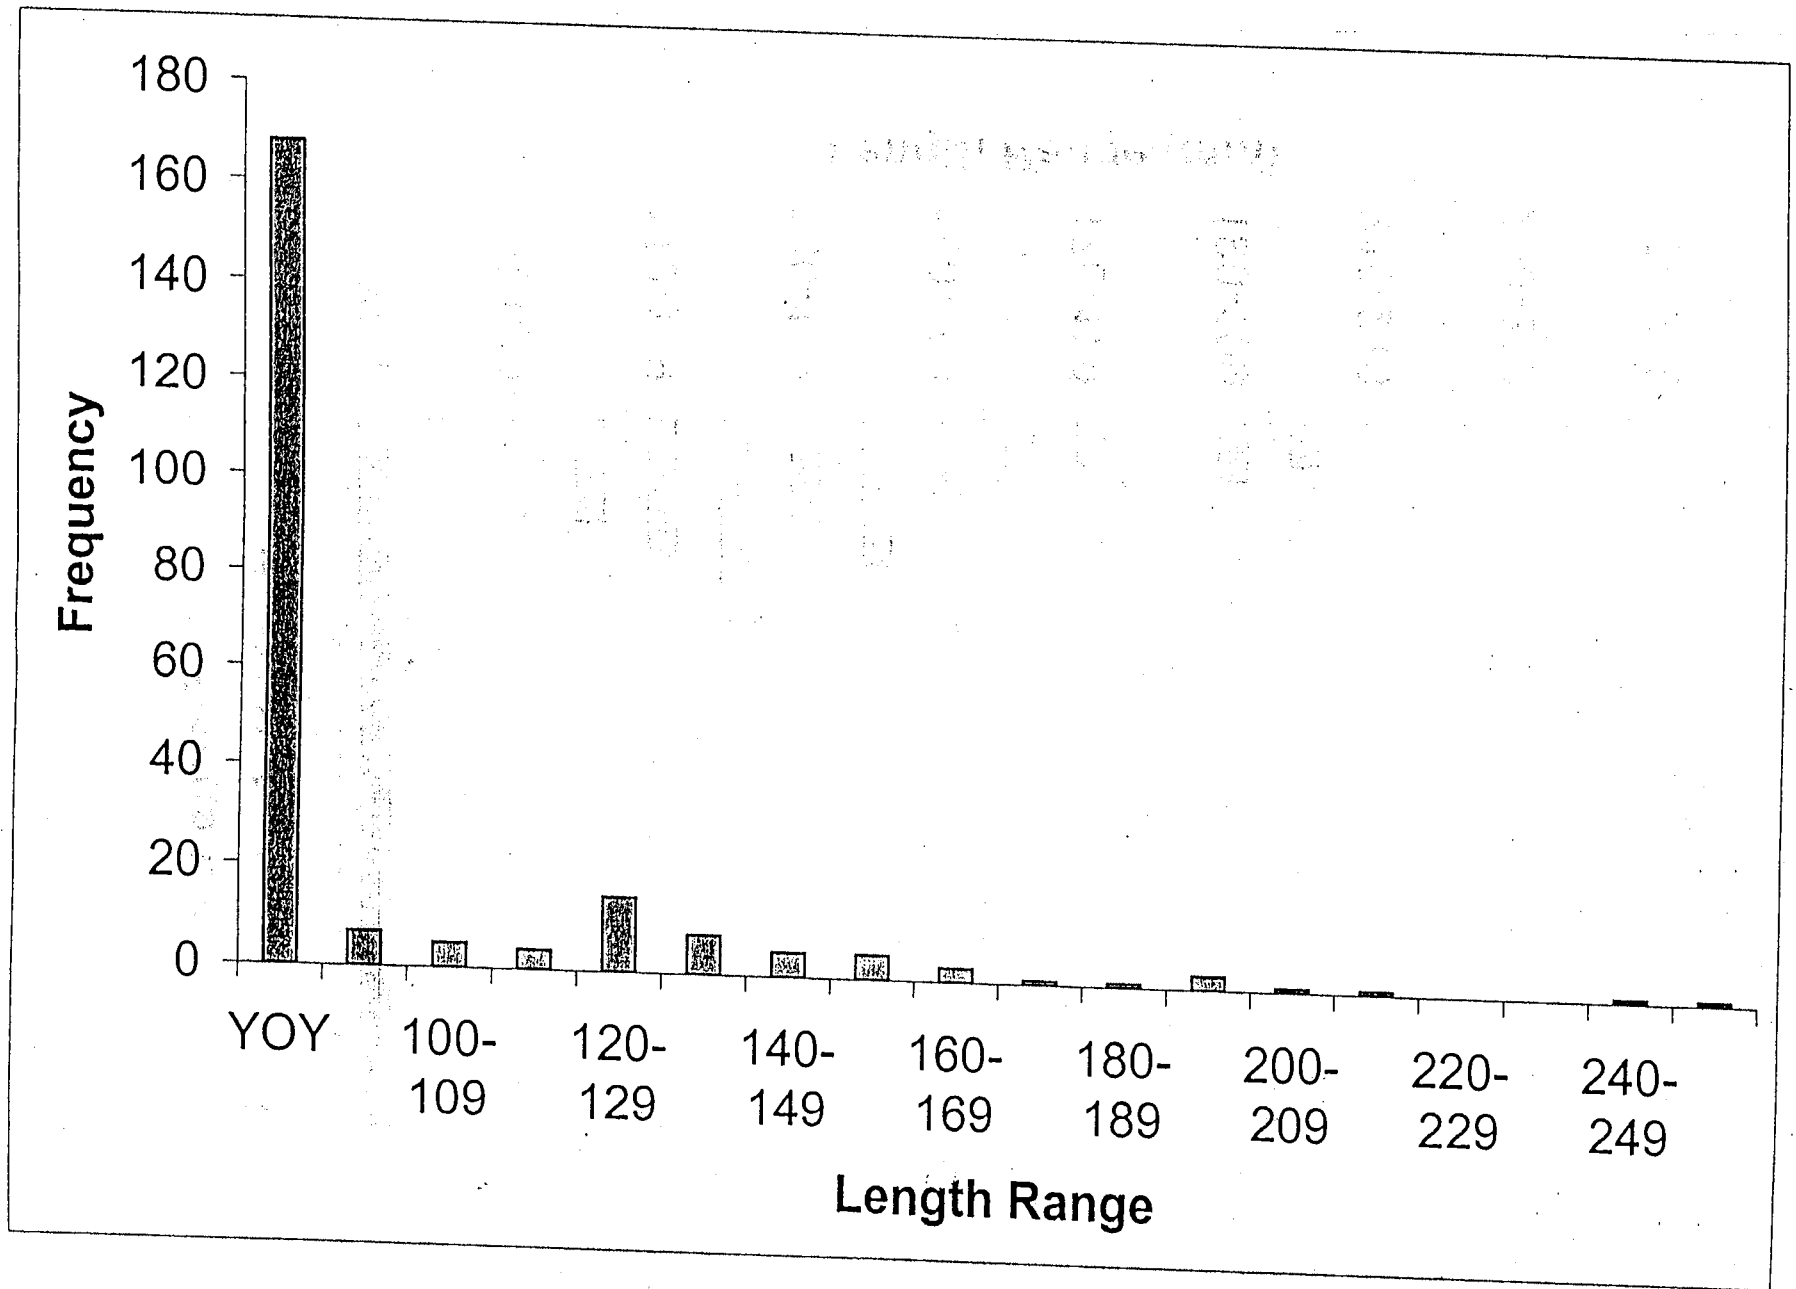
(Figure 19). Brook trout (3898/ha) was the most abundant fish species in this reach, followed by mottled sculpin (732 per hectare) (Table 16). Seventy-three percent of the brook trout captured were YOY (Figure 22). Eight (3.5%) of the 229 brook trout captured were of legal size. Only 1 brook stickleback was found in this reach.

Figure 22. Length-frequency chart for brook trout in Reach C of the Dead River bypassed channel, August 2000.

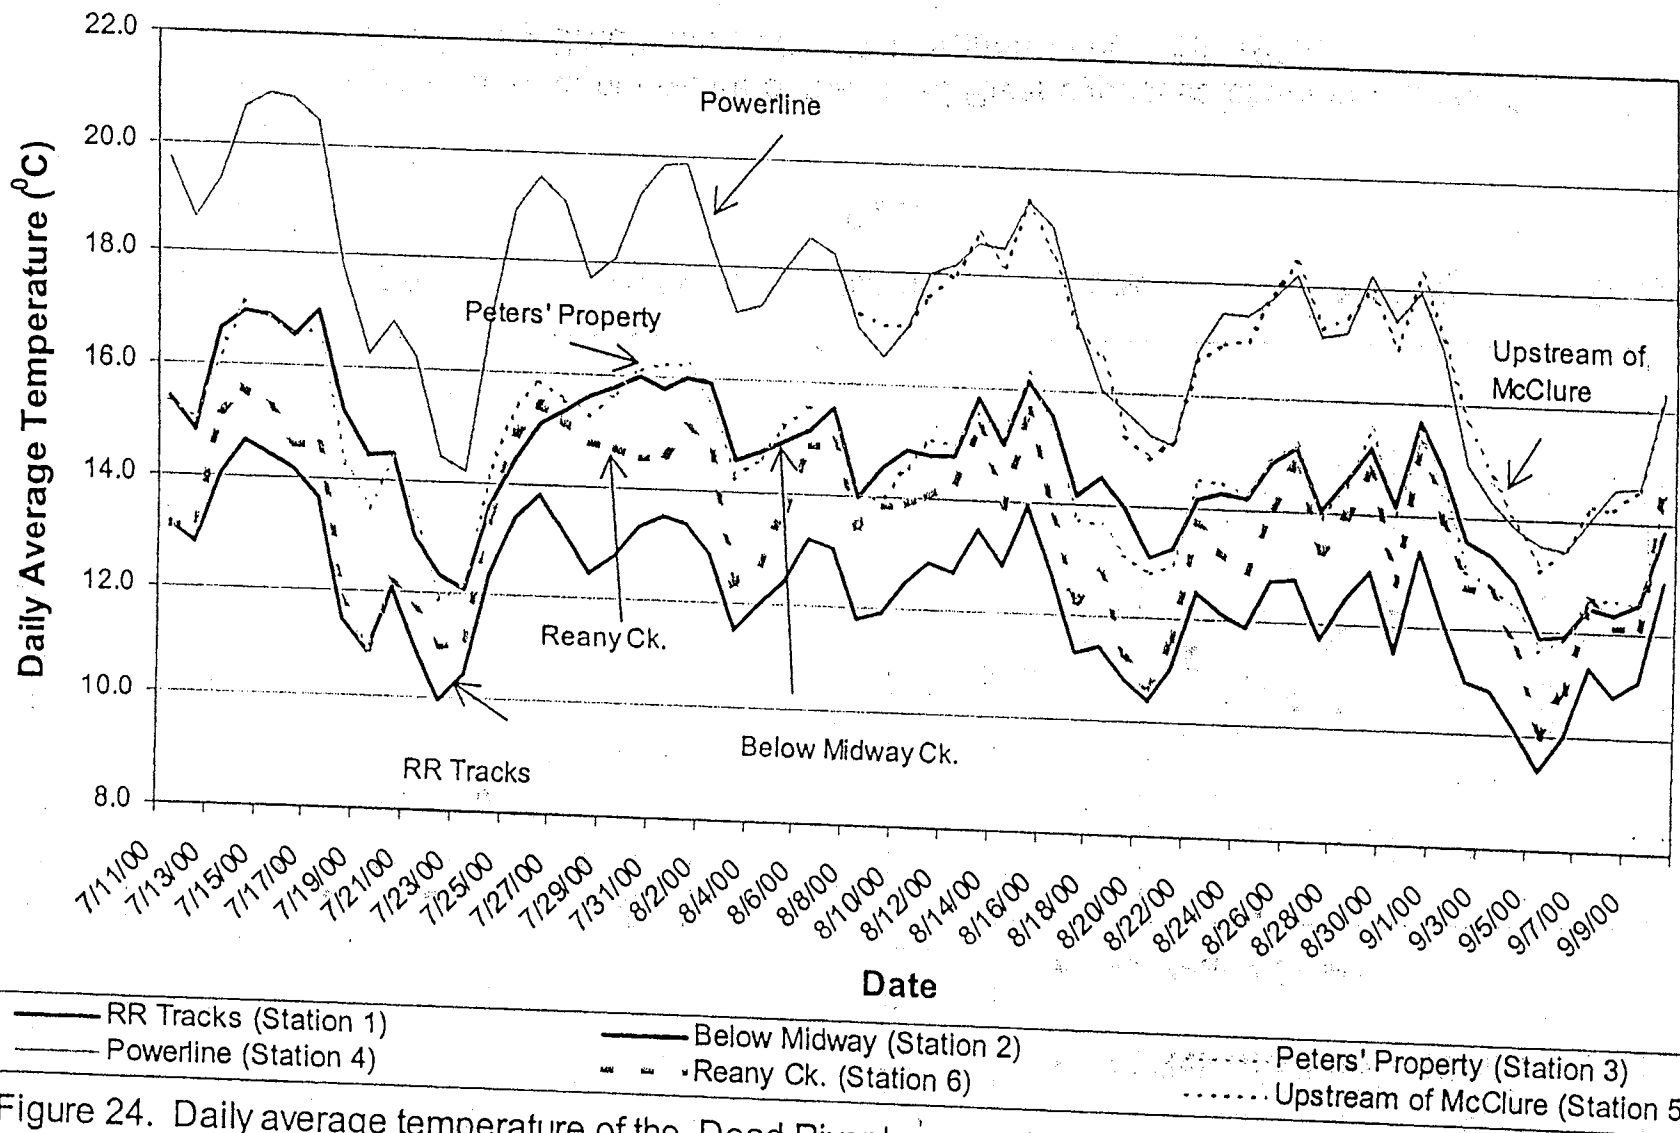
The data show a general pattern of increasing temperature in the Dead River bypassed channel from Station 1 (railroad trestle) to Station 4 (powerline crossing), during the 2000 monitoring period (Tables 18-19, Figure 24). Average temperature increased by 2.4 °C from Station 1 to Station 2, but remained stable between Stations 2 and 3 due to the cooling influence of an unnamed tributary upstream of Station 3. Average temperature at Station 4 was 2.9 °C warmer than at Station 3, and 5.2 °C warmer than at Station 1. During the July 20-22, 1999 monitoring period, the water at Station 1 (Railroad Trestle) was much warmer than normal because water from the surface of the McClure impoundment was spilling over the top of the dam, which is an unusual occurrence. All stations in the Dead River bypassed channel and Reany Creek met the coldwater temperature standard (Rule 323.1082 of the Michigan Water Quality Standards).

Figure 24. Daily average temperature of the Dead River bypassed channel and Reany Creek (July 11-September 10, 2000). Data at Station 3 were collected by MDNR Fisheries Division.
